Rear Window Regulator Fix

This is my first attempt to fix the dreaded window regulator issue. It happened on a friend's 320d to the rear left passenger door.

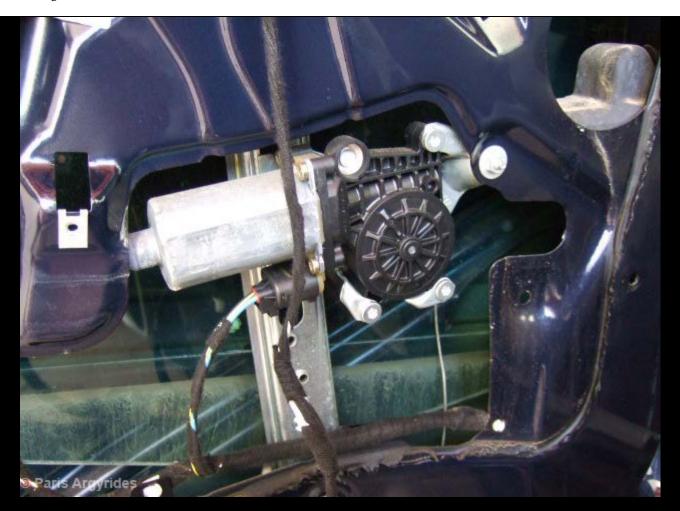
Glass up (or down) steel wire loose. Now, at this point I realized that more damage had happened and not just the small and easily repairable window regulator. So I had to remove almost everything to get the whole mechanism out. You may skip these steps if you are just fixing the window regulator.

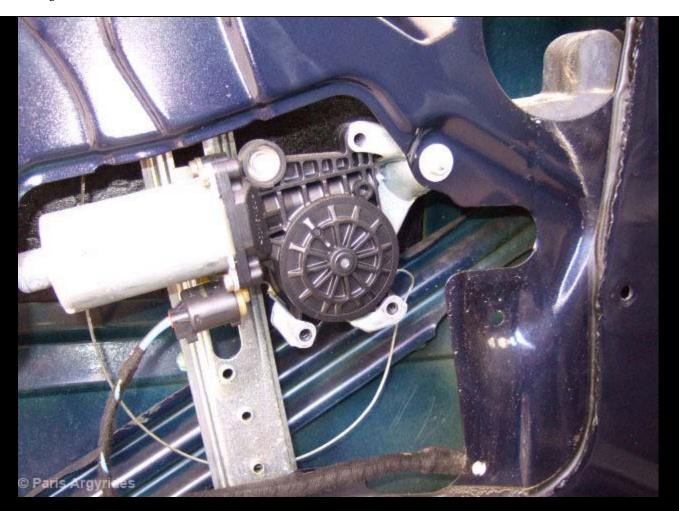
Motor gear seal in pieces!!! I wonder if that seal is sold separately

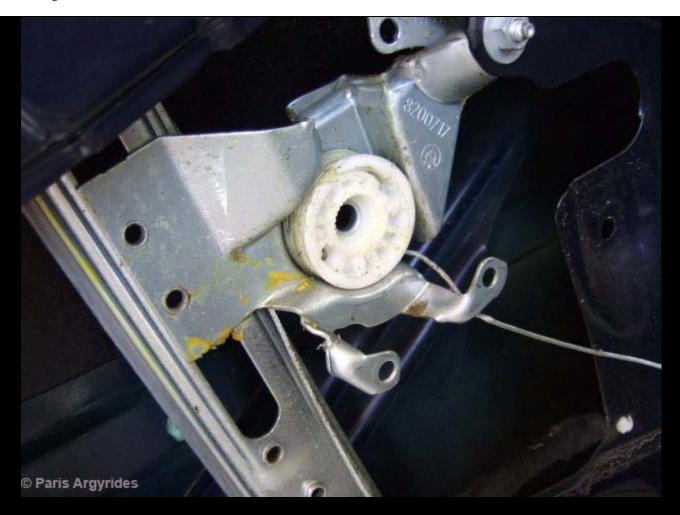
Chewed steel wires

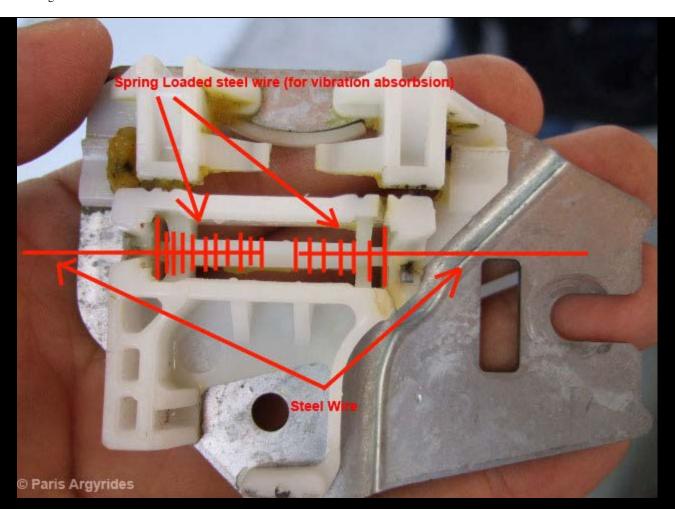
Here's where the poor design comes into place. Why on earth would you make a plastic mechanism to hold a permanently on tension steel wire which gets abused every day? The plastic snapped, allowing the steel wire to come out of place. It took me some time to remove the grease in order to repair this.

To repair the broken window cylinder, I fitted a metal washer and covered it in glue. There's plenty of space so use plenty of glue.

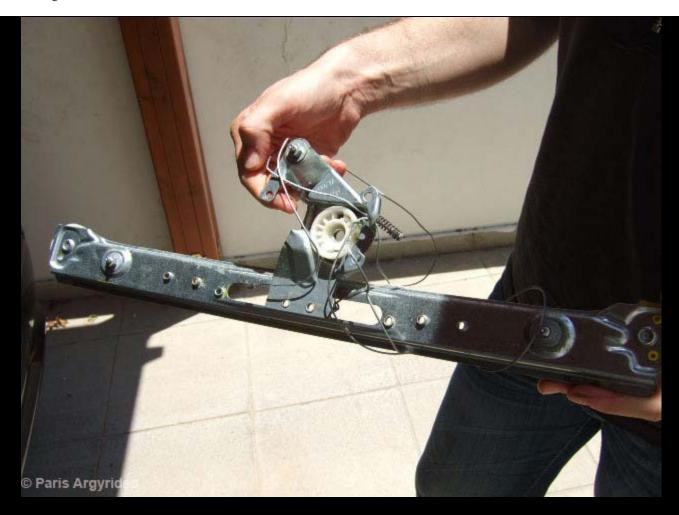
What a mess!

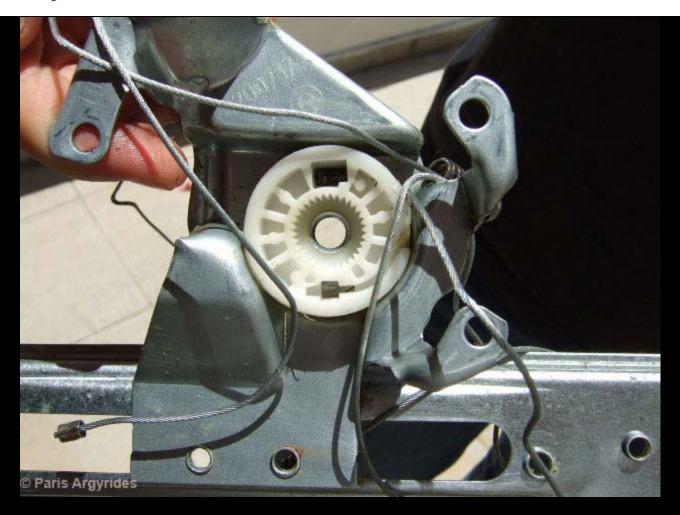
This guide was wobbling when I checked it so it needed replacement.
