Antenna Booster Replacing

This is the first step to fix the crap FM reception of my BMW, after fitting an Alpine CDE-9873RB headunit. I replaced the OEM booster with another OEM booster of later production date.

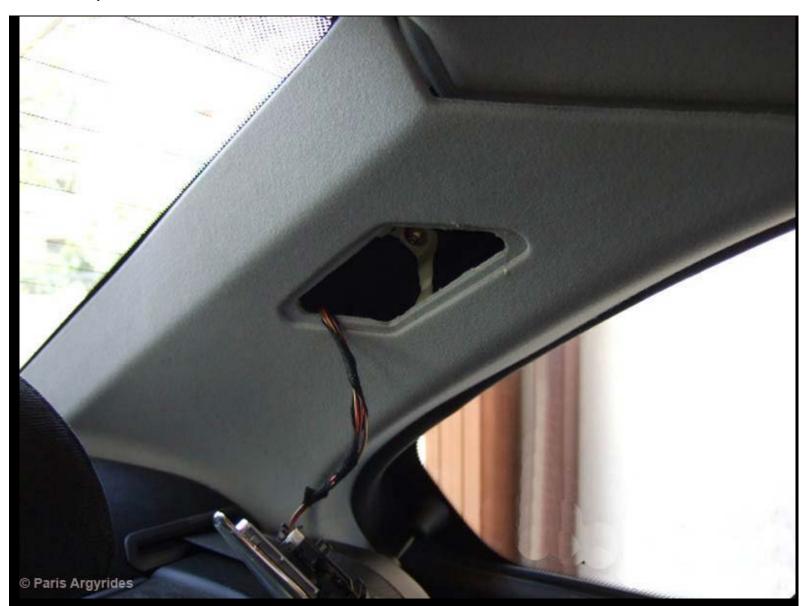
Here's the antenna booster. It is held by two T25 screws. One of them (bottom) was a PITA to remove due to its awkward position. I had to use a combination of tools to get it out.

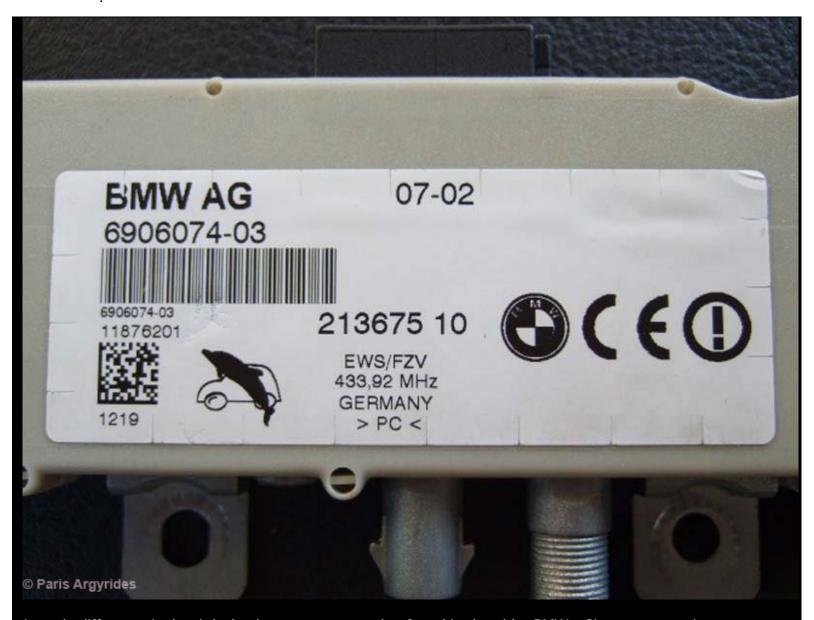
Its only difference is that it lacks the aux. antenna plug found in the older BMWs. Since we are using an aftermarket Headunit, the aux antenna is not needed.

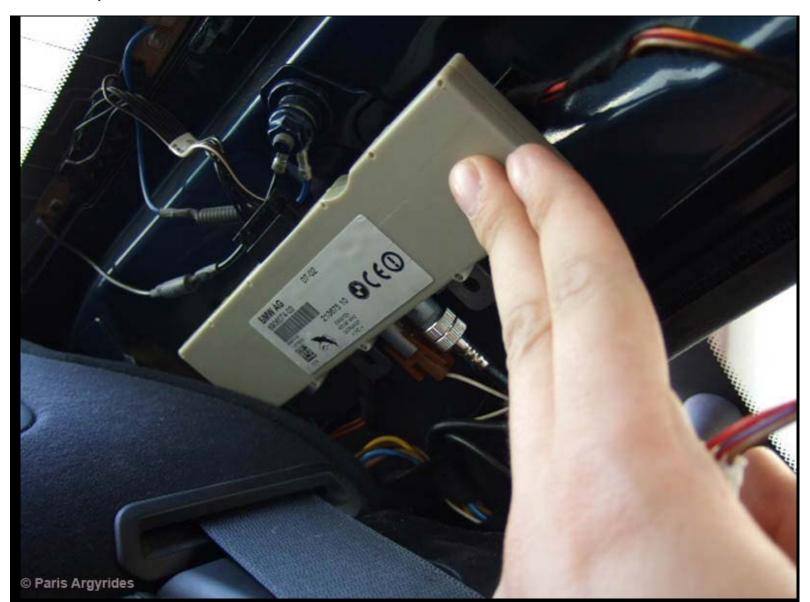
After taking the time to do the replacement, I found out that my reception has not improved. Next step is to replace the antenna wire to the headunit.
