Not much to be said other than replacing the slipring upon turning the steering wheel I heard a snap, and lost all control on the steering wheel, including horn and airbag. It was evident that the slipring failed miserably. I bought a new one from dealerShip as am not fond of putting used parts that have mechanical movement on my car. First and foremost, I disconnected the battery negative terminal.

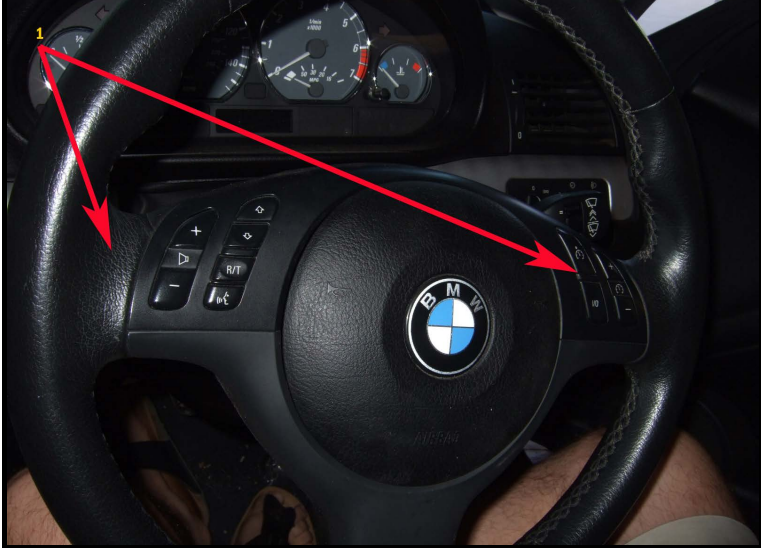
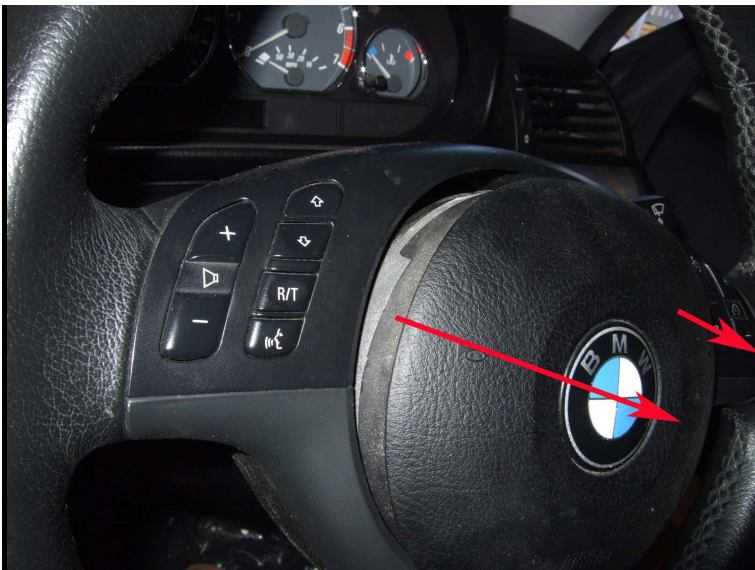
1. Insert a flathead screwdriver at the 2 openings behind the steering wheel and slightly push the screwdriver until you spot the 2 airbag retaining springs. The screwdriver should be set horizontally with a slight angle upwards, and closer to the steering wheel rather than the dash. Once you feel the spring on each side, push it and with the other hand, gently pry the airbag out.

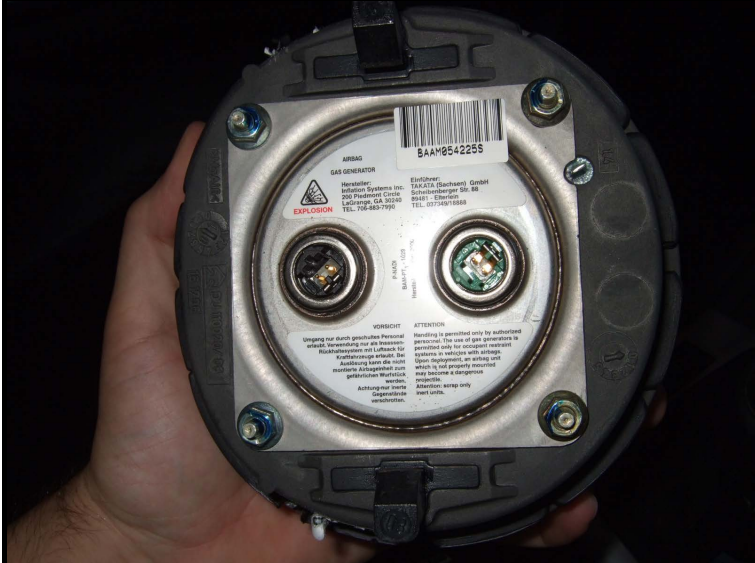
Disconnect the 2 plugs from the wiring. There are locking plugs, so you need to use a flathead screwdriver to pop the lock on each plug in order to pull it out without breaking anything.

1. Retaining springs mentioned above
2. Disconnect all plugs from the wiring
3. Remove the 16mm ball that secures the steering wheel on the shaft

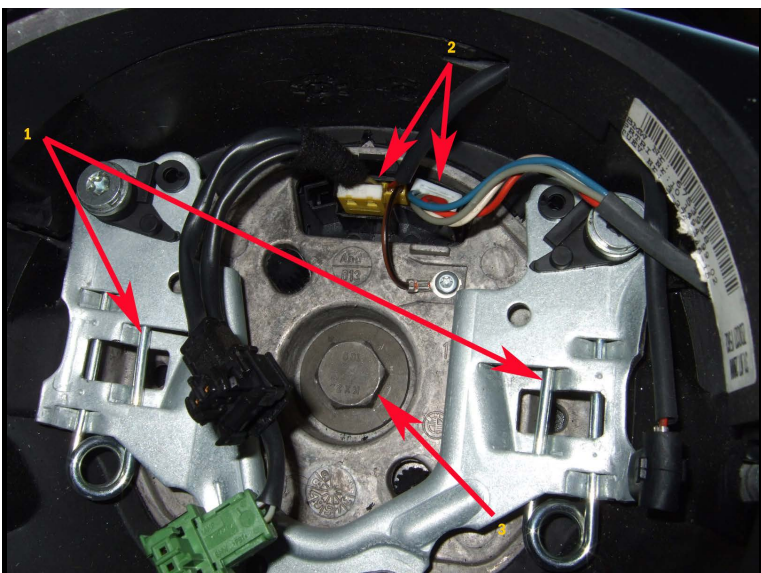
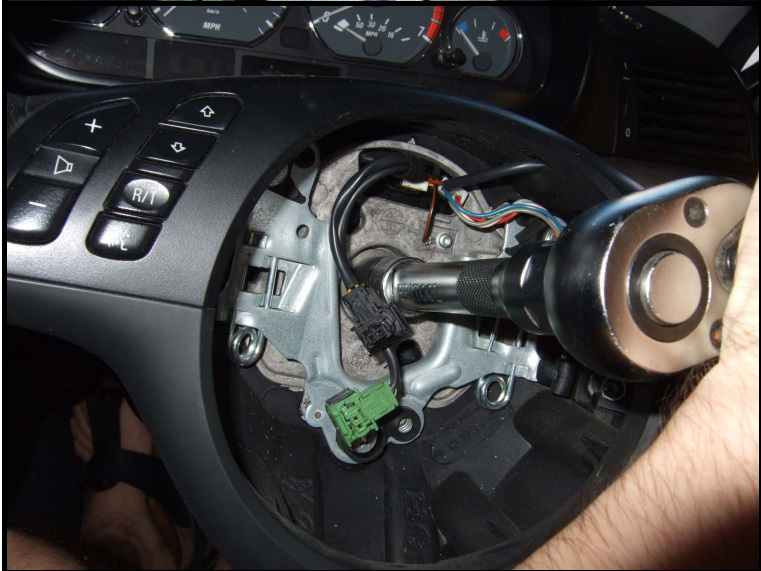
Notes the alignment mark on the steering wheel and on the shaft, this is to be able to place the steering wheel to the correct position.

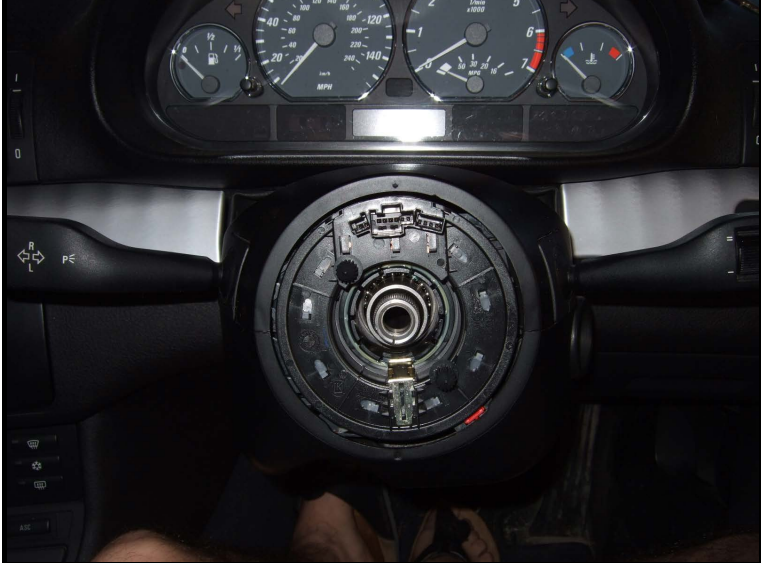
Once the steering wheel is out, you will see the slipring with the wires attached on it.
In order to remove it, the upper and lower steering shaft covers must be lifted slightly. There is 1 plastic phillips screw on the top cover and one L-LOCK push/lock pin on the bottom cover. Remove both.

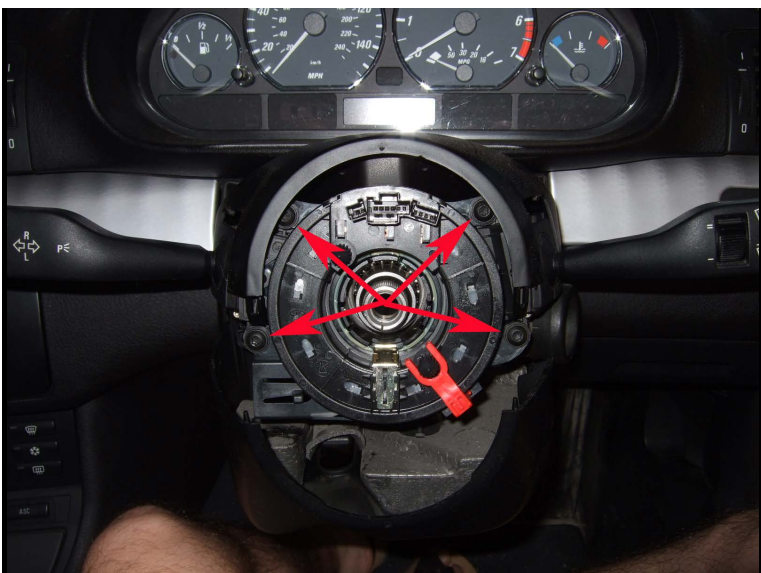
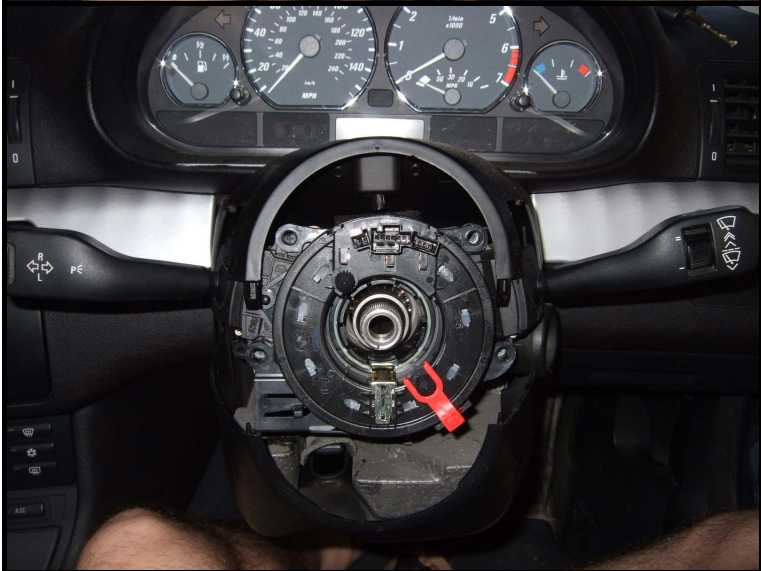
After removing them, gently separate the two covers. You will expose 4 T22 screws. Remove them. (Picture is with the new slipring attached)

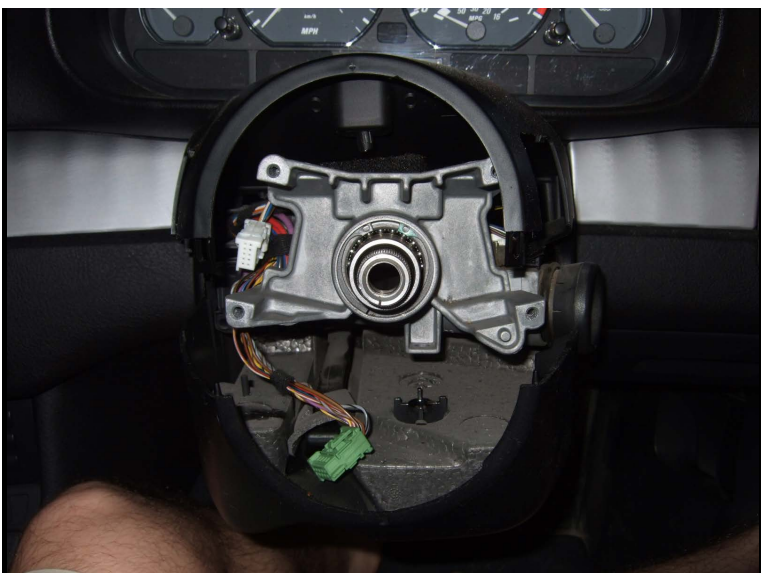
Put the vibration bit and disconnect the indicator, wipers, and steering control plugs.

- 1. Plug to disconnect
- 2. Remove indicator and wiper stalks by pushing the 2 lock tabs and pulling them away from the slipring. They will slide out easily.

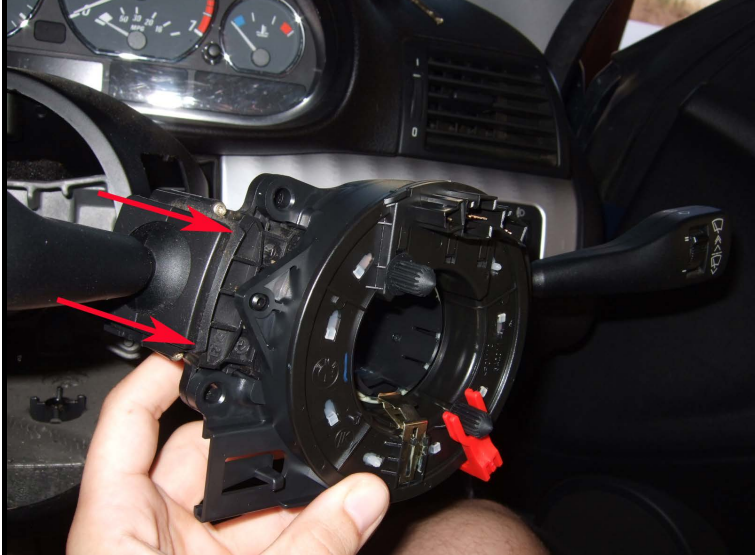
Slide the 2 sticks back in place and make sure they are locked (characteristic sound of the plastic locking tabs).
 Reconnect all 3 plugs on the back of the lighting, screw the 4 T20 screws and close upper and lower steering wheel covers. Replace the plastic screw and lock pin if damaged.

1. Snap the red plastic by pulling it away from the lighting. This is installed from factory to prevent accidental turning of the lighting housing everything. This is an extra safety as the lighting still cannot turn freely due to that spring on its bottom. The spring is allowed to move only when the steering wheel is twisted, which basically pushes the spring downwards.

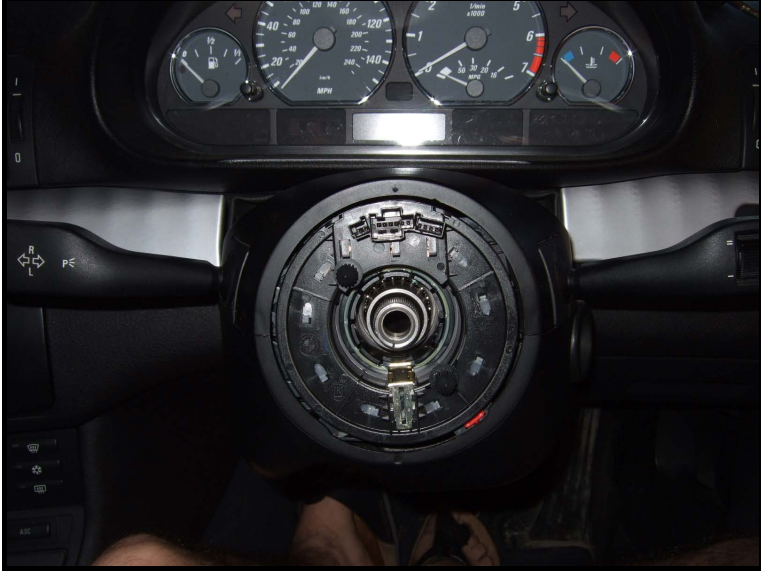
This is the new slipring installed, with the covers back in place

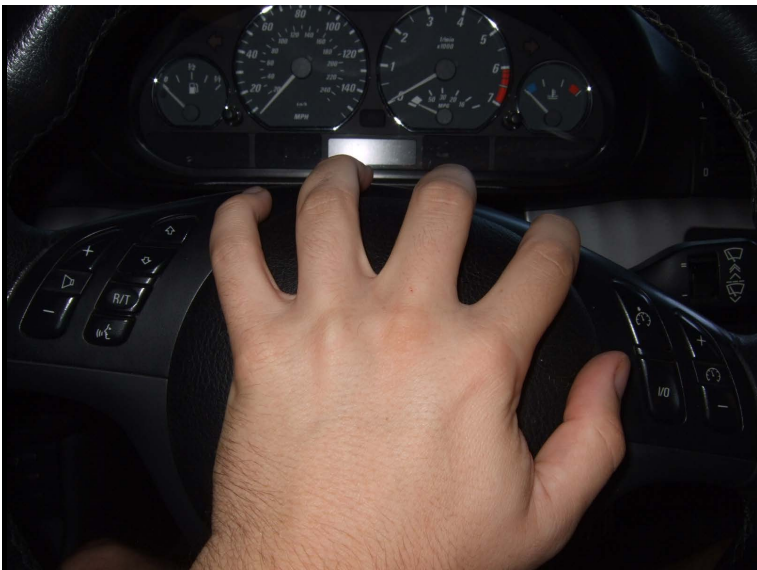
Insert the steering wheel back - align - reposition all plugs - ensure the 1st plug back and fully - plug in the 2nd plug, making sure they are locked on.
Put the spring on the steering wheel in position and push it in until it locks in place.

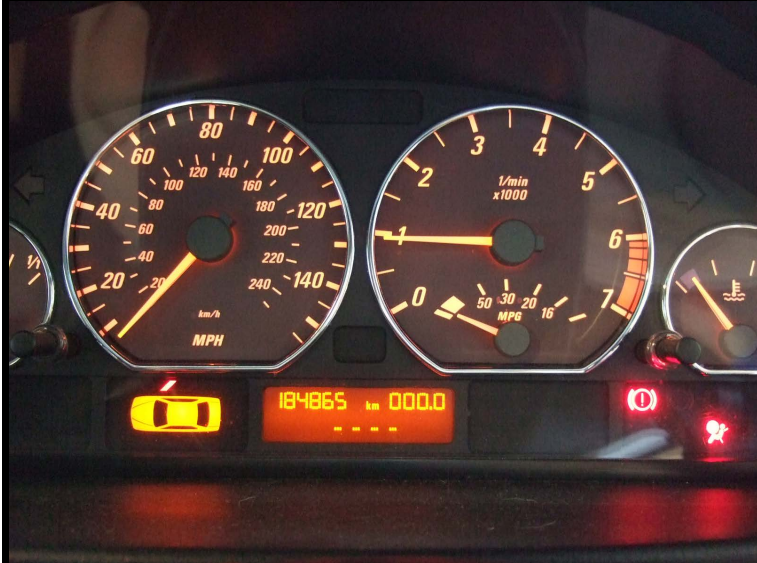
Old slipping the problem is apparent.
