Rear Window Regulator Fix

This is my first attempt to fix the dreaded window regulator issue. It happened on a friend's 320d to the rear left passenger door.

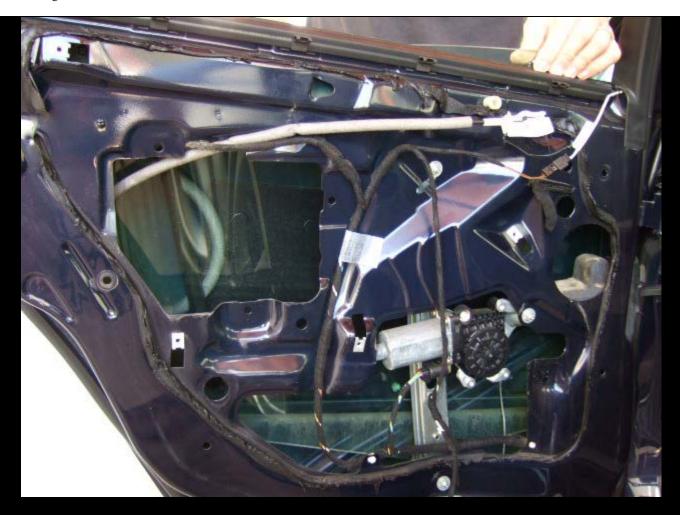
Window motor closer.

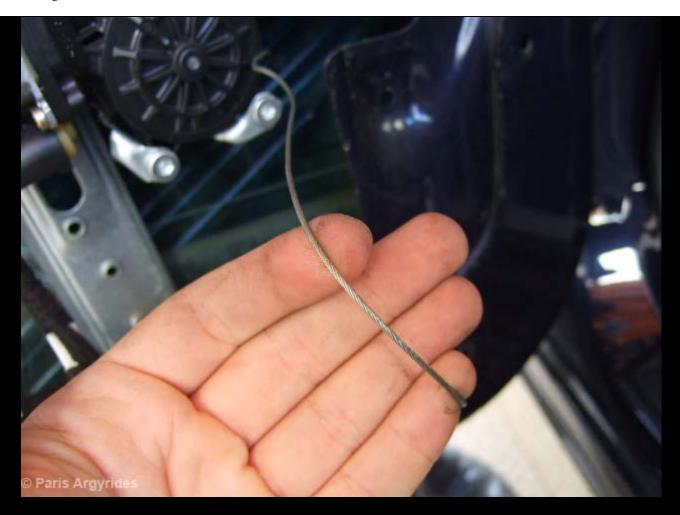
Glass up (or down) steel wire loose. Now, at this point I realized that more damage had happened and not just the small and easily repairable window regulator. So I had to remove almost everything to get the whole mechanism out. You may skip these steps if you are just fixing the window regulator.

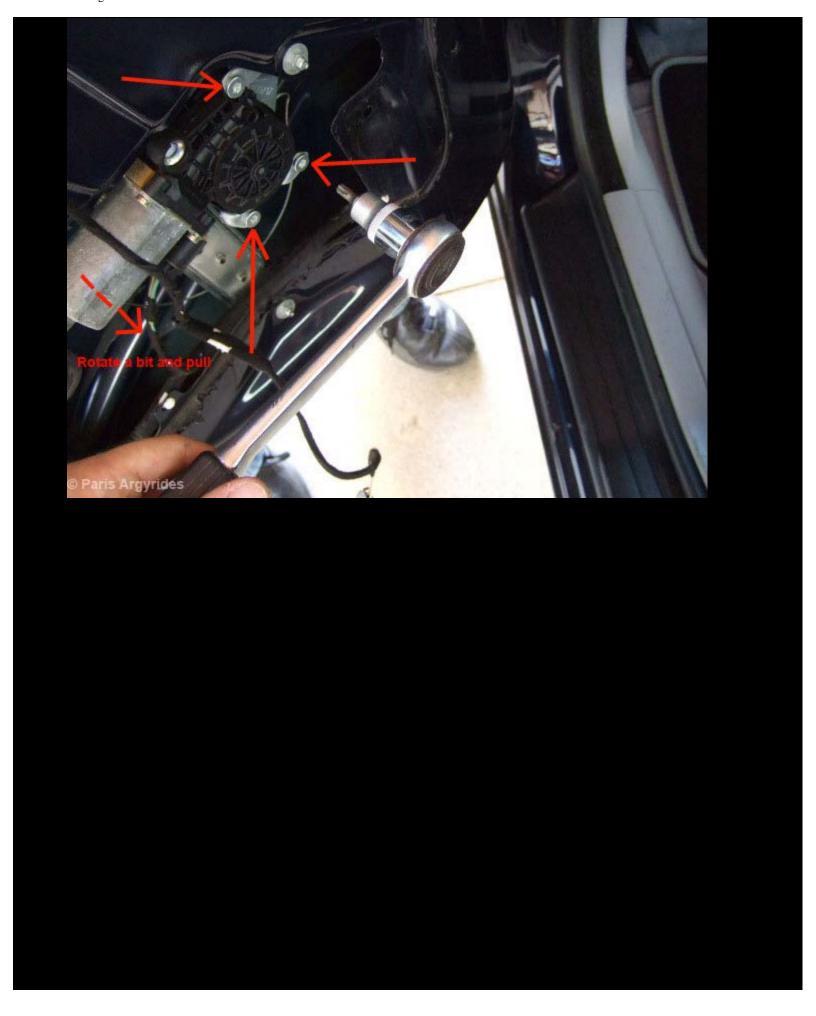
Motor gear seal in pieces!!! I wonder if that seal is sold separately

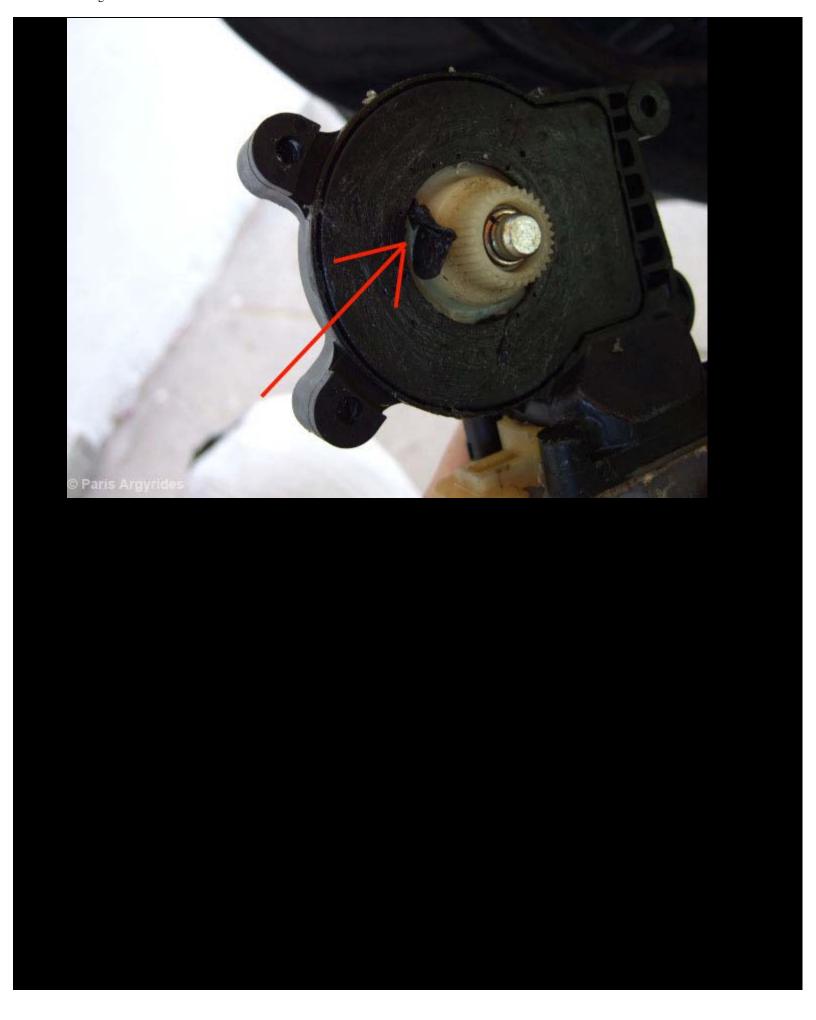
This plastic gear/rail has the steel wires wrapped around it and is powered by the motor. The wires were such in bad shape that had to be replaced, hence the removal of the mechanism.

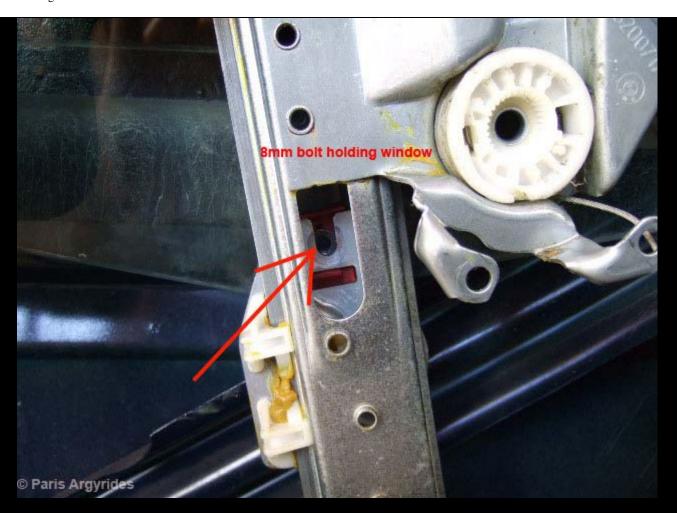
Here's how it was supposed to be. 2 steel wires are located in the cylinder. One is for moving the window up, the other for moving it down. They were spring loaded to perhaps allow some up/down movement of the glass and to prevent vibrations.

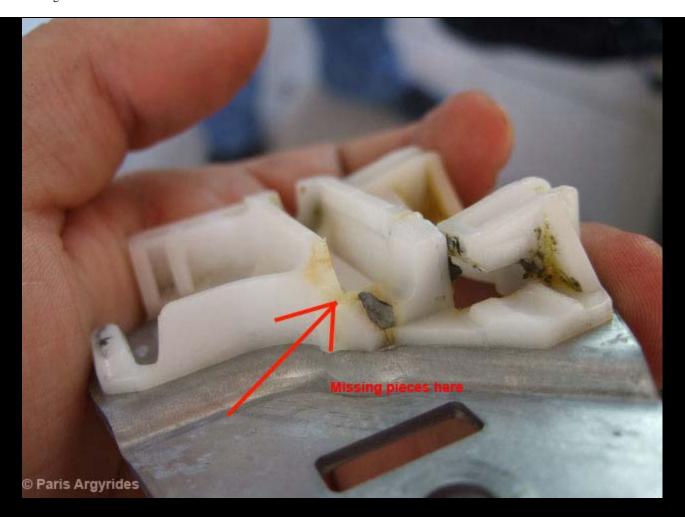
Here's where the poor design comes into place. Why on earth would you make a plastic mechanism to hold a permanently on tension steel wire which gets abused every day? The plastic snapped, allowing the steel wire to come out of place. It took me some time to remove the grease in order to repair this.

Because of the extent of the damage, I decided to remove the whole window mechanism to see what is repairable and not. It's held into place with 3 10mm bolts

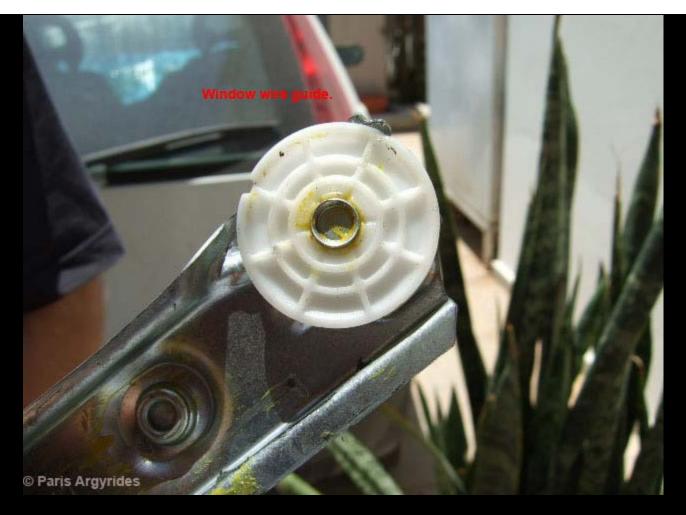
This guide was wobbling when I checked it so it needed replacement.

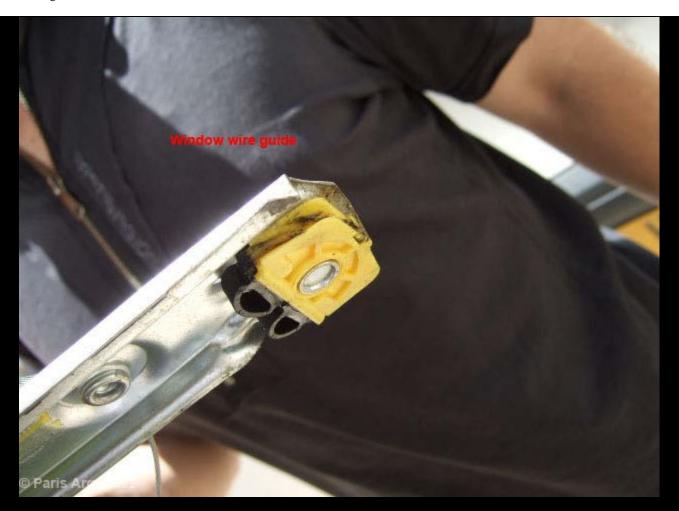
Another guide but not worn

Since a new window mechanism was required, I took my time to try and repair the current window guide to have it as a spare. I used this glue. Bison epoxy metal. It takes 2 days to dry but once dry, it will never come off

again.

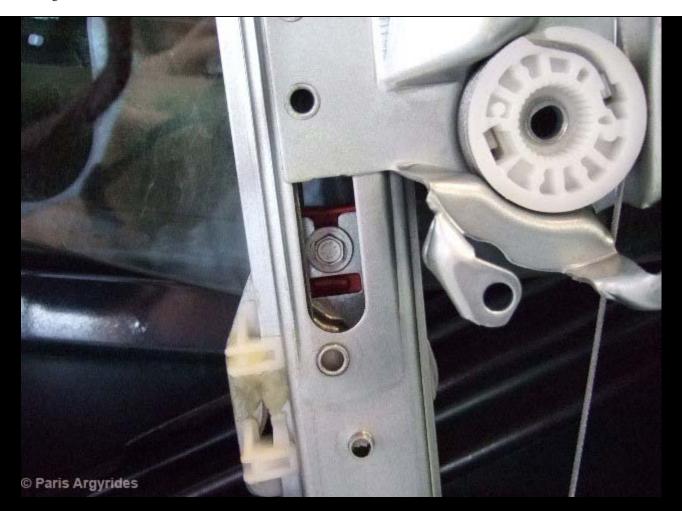
Apparently the glass now moves faster than the glass on the other side. I wonder if the right window regulator is on its way as well... Time will show

Re-installed the window motor and tested before final door assembly.
