Antenna Booster Replacing

This is the first step to fix the crap FM reception of my BMW, after fitting an Alpine CDE-9873RB headunit. I replaced the OEM booster with another OEM booster of later production date.

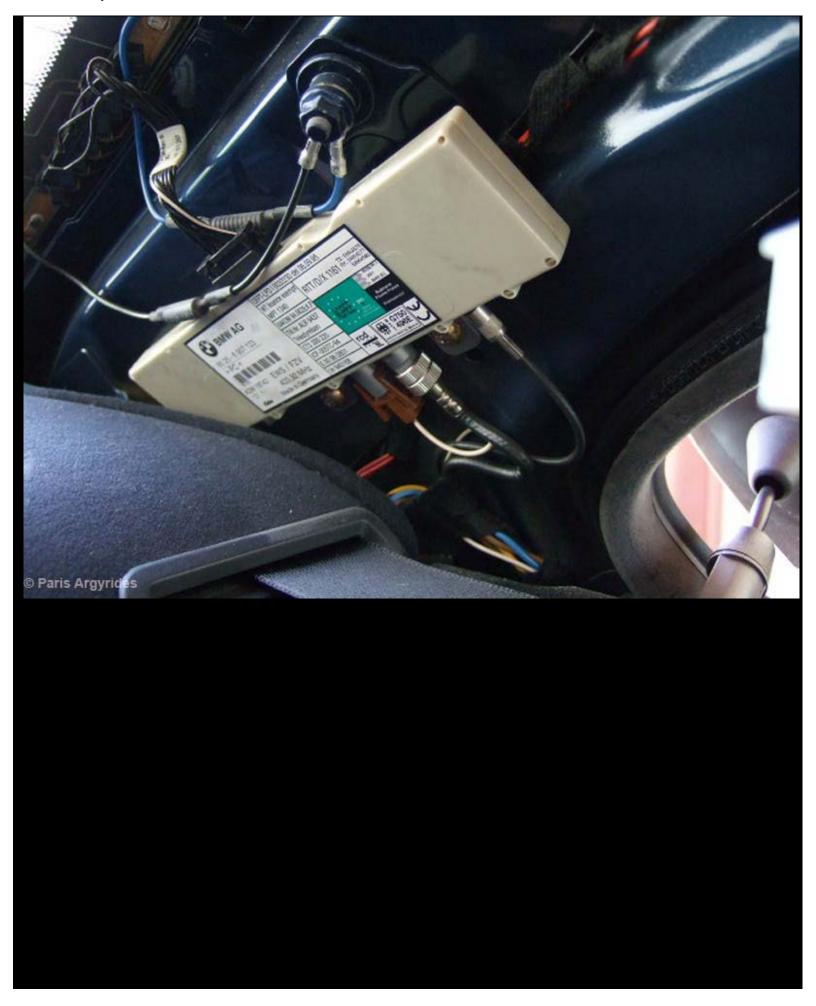
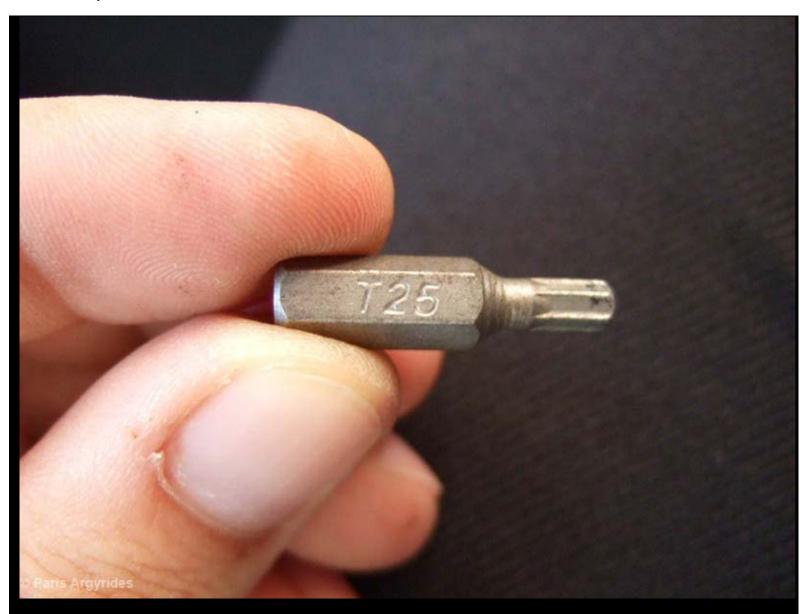
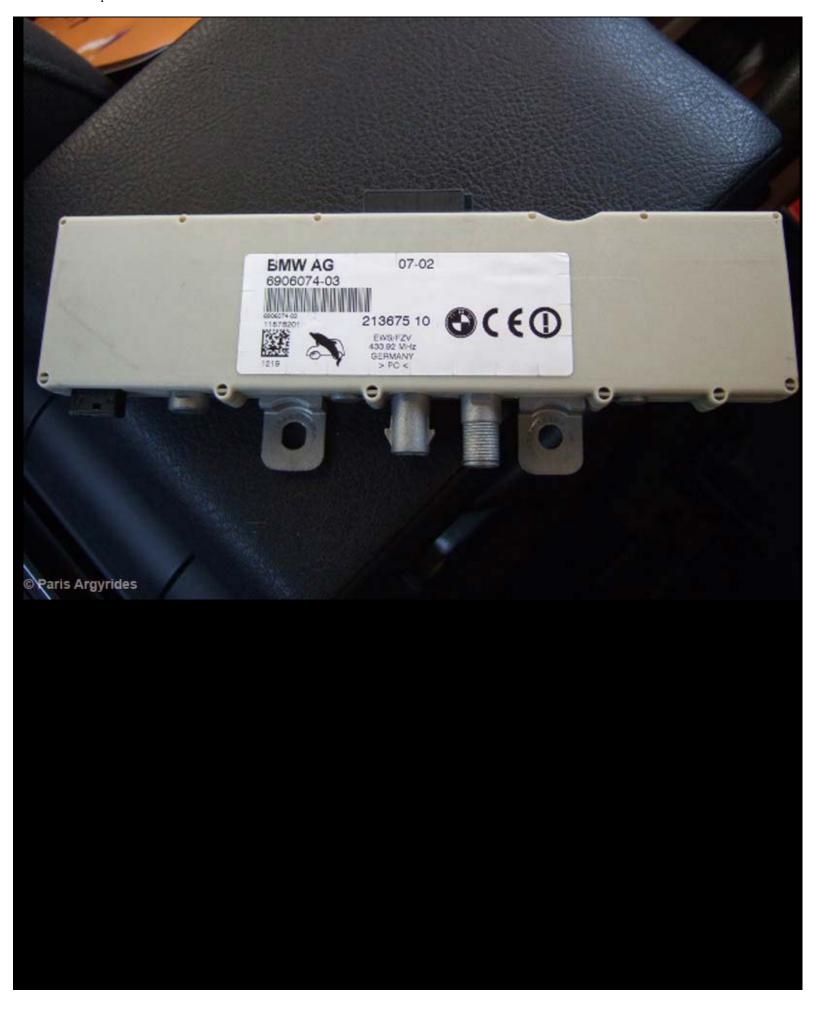
Here's the antenna booster. It is held by two T25 screws. One of them (bottom) was a PITA to remove due to its awkward position. I had to use a combination of tools to get it out.

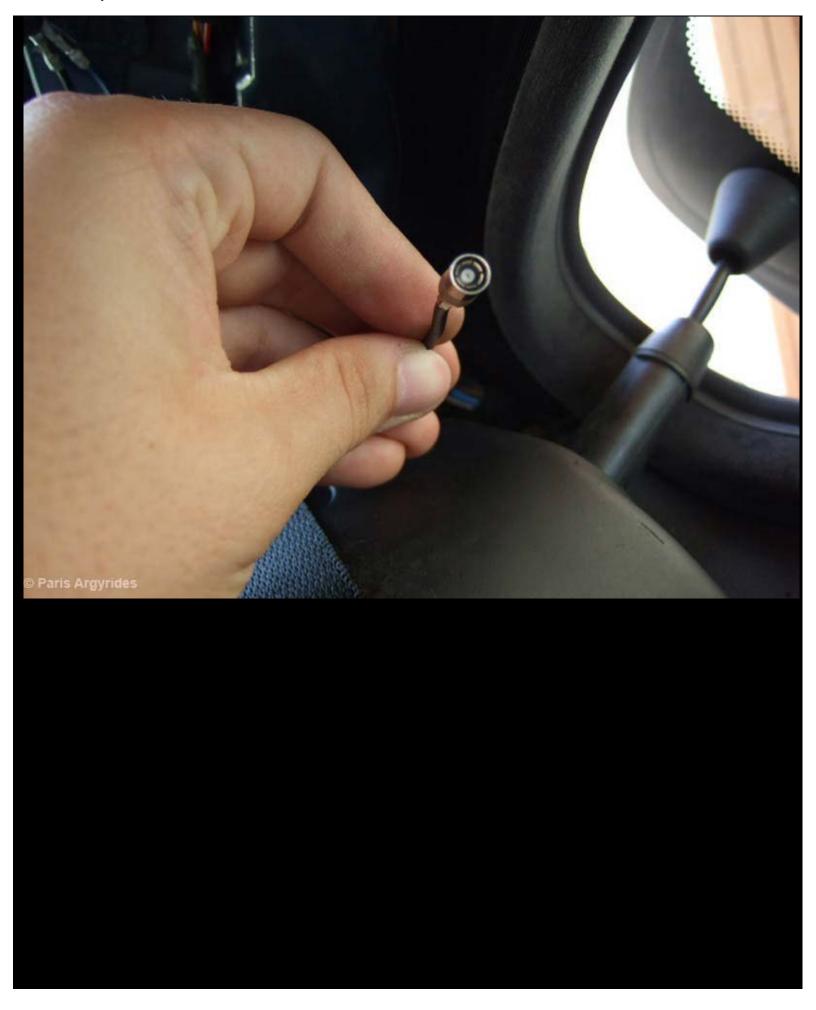
Its only difference is that it lacks the aux. antenna plug found in the older BMWs. Since we are using an aftermarket Headunit, the aux antenna is not needed.

Insert in place, connect all cables (except the aux. antenna) and reverse procedure to insert screws, liner and passenger lights.
