Steering Wheel Joint Replacement

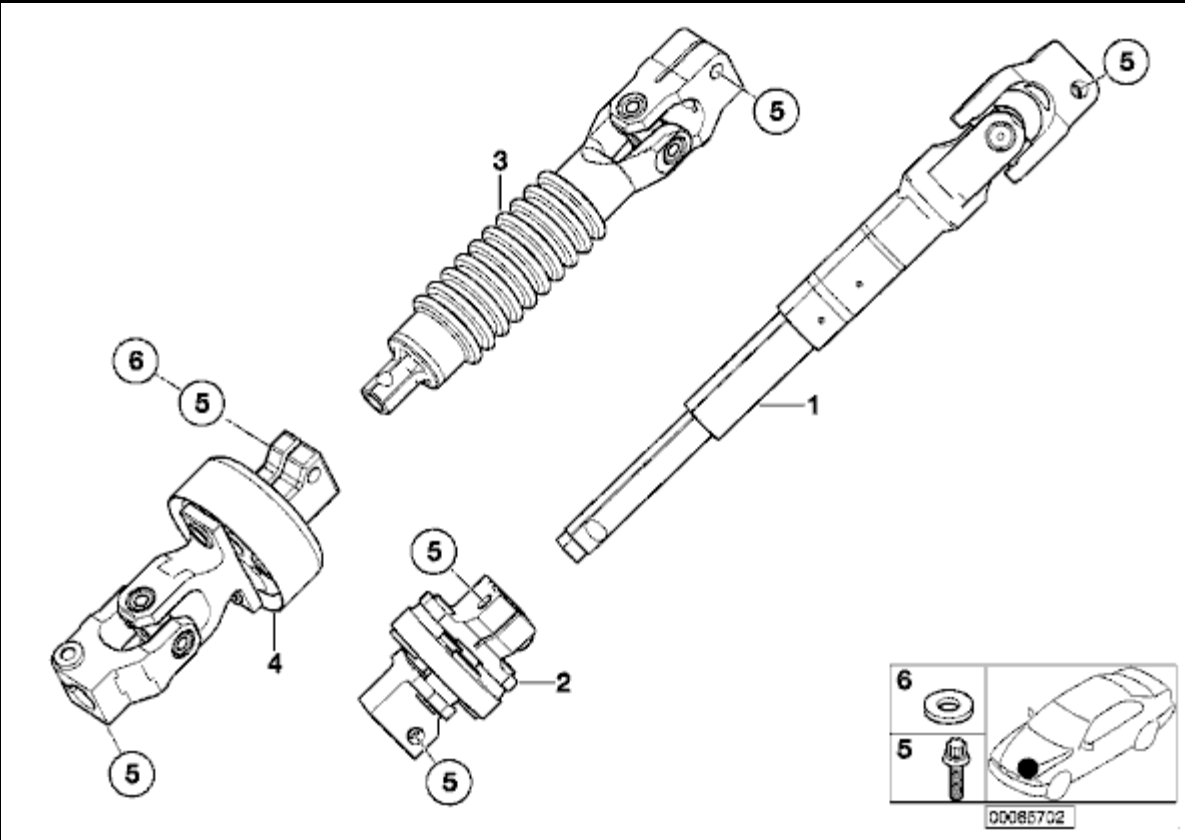
When turning the steering wheel, either left or right, I could hear a clicking sound and feel some kind of gap, i.e. when a gear misses a tooth. After a visit at the mechanic, he pointed me that the steering wheel joint (Item #4) bush was out, causing the "play" and the weird sounds.

No.	Description	Supplement	Qty	From	Up To	Part Number	Price	Notes
03	LOWER JOINT ASSY		1		02/2002	32301094704		+core, ENDED
03	LOWER JOINT ASSY		1		11/2003	32306761570		+core
03	LOWER JOINT ASSY		1	11/2003		32306764007		+core
04	SWIVEL JOINT WITH UNIVERSAL JOINT		1			32306761571	\$94.86	+core
05	TORX BOLT	M8X33	3			32301094718	\$0.56

1. Remove the 2 torx bolts (Item #5).
2. Have another person get inside the car
3. Remove the cover under the steering wheel
4. Let the person inside the car pull the steering shaft towards him.
5. Then the joint can be removed.
6. Install the new joint paying attention not to turn the steering wheel left or right so that you lose the centre. (I forgot that and in order to move straight, I had to have my steering wheel

turned around 10 degrees clockwise). If you miss the centre, you can go to a shop and have them align the wheels with the steering wheel.

7. Bolt the 2 torx screws and use Loctite as well.
