"Wobbly" M3 Mirror Fix

After 2 years of use, I noticed that my genuine M3 mirrors would "wobble" a bit at the point where the fixed baseplate meets the mirror housing. Since the mirror housing was shaking while I was driving, it quickly became annoying so a fix was mandatory. Thankfully, no serious dismantling is required to do this fix. In fact, just 2 bolts and a cover to be removed.

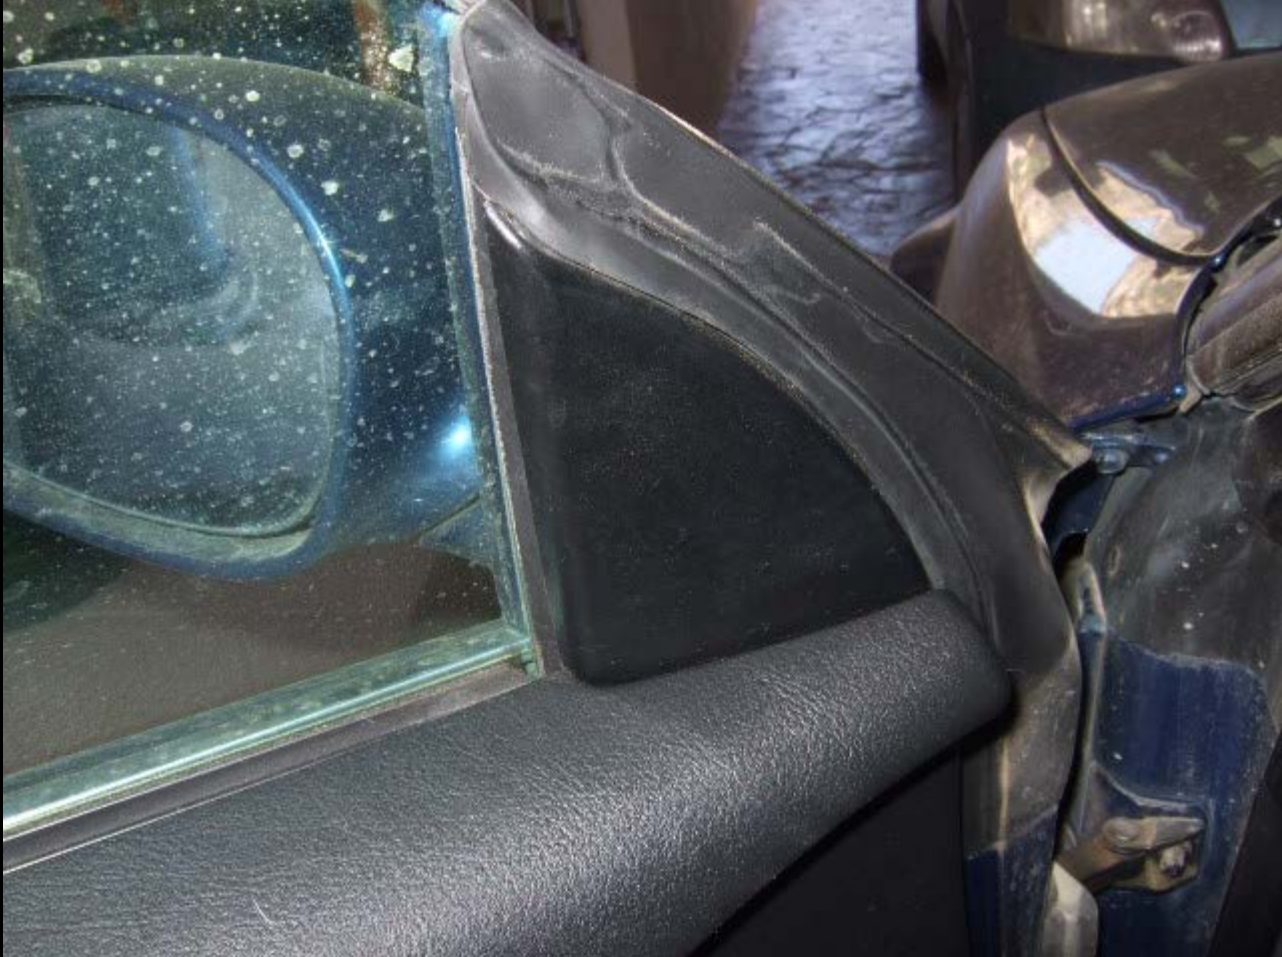
Remove the cabin mirror cover:

Grab the top section and pull towards you until it unclips, then lift upwards to completely remove.

See the bottom hole how it is shaped, that's why you need to pull upwards when the top part unclips. Now remove the 2x 10mm bolts while holding the mirror in place.

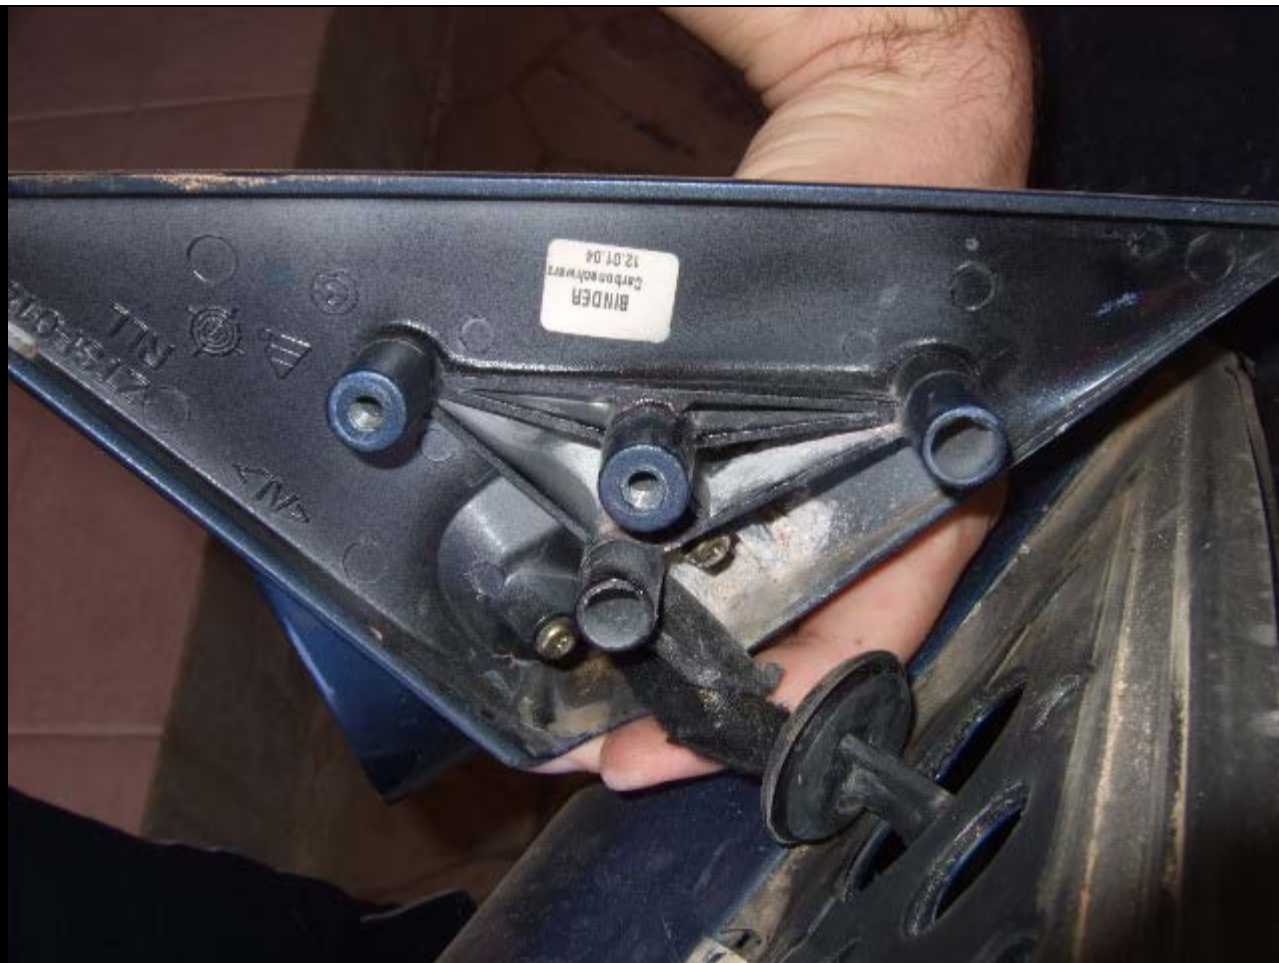
The wiring is just enough to let you work behind the mirror plate. Pull the rubber sealing grommet outside. Carefully remove the foamy gasket from the base plate to reveal 2x T20 screws. These were loose in my case. I took a ratchet and tightened them enough to stop the housing from moving around on its own. As these things are fragile, careful not to overtighten.

Once tight, replace the foamy gasket, grab the rubber grommet from the inside and pull it until it goes back in to place. <- Important step else water might enter the door card and you don't want this to happen! Re-install the 2x10mm bolts and finally re-insert the black cover. The plastic cover first goes in the bottom hole, then you push it downwards and then you push the top section to clip in place. It's pretty intuitive.
